DEPARTMENT OF TRANSPORT

# Investigation into the Clapham Junction Railway Accident

Anthony Hidden QC

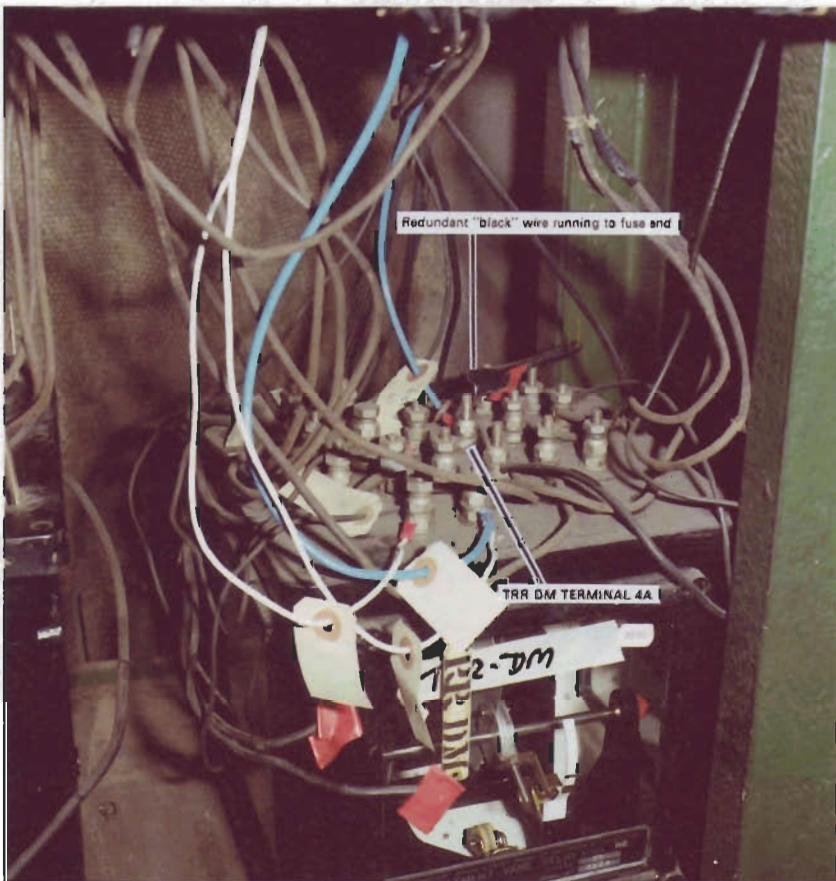
**Fig 13.** Relay TRR DM taken on 12 December at approximately 14.00 hours.

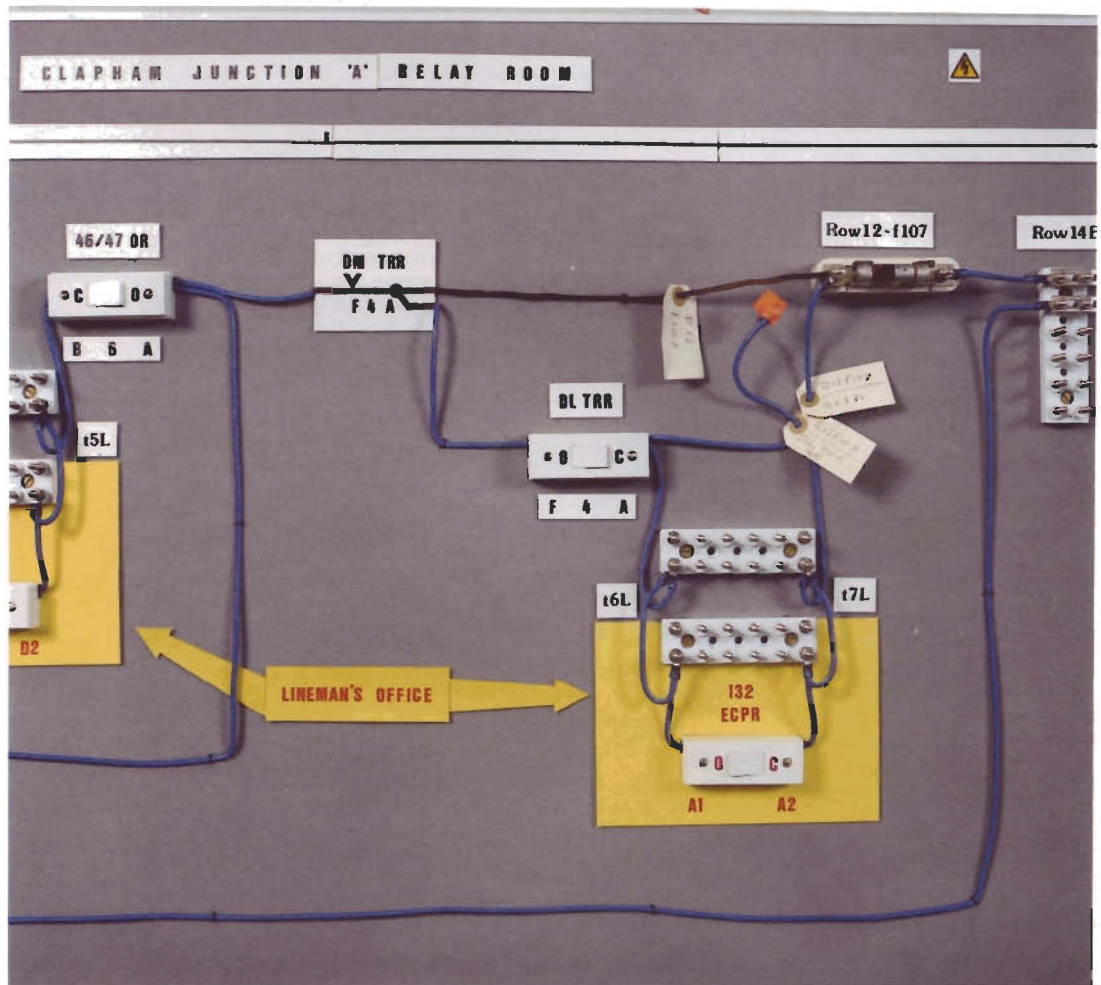
Extract from the working model demonstrating Job Nos. 104 and 201 and the wiring errors made. The black wire along the top of the diagram connected at DM TRR and Row 12-f107 should have been disconnected at both ends but was wrongly left connected at the fuse end of Row 12-f107. Although disconnected at the relay end the wire was left loose and made metal-to-metal contact at DM TRR, a false feed of current to by-pass DL TRR. Hence the occupation of track circuit DL by a train had no effect on signal WF138 and it did not turn back to red as it should have done.

1.25 Everything else involved in the track circuit might be working perfectly correctly, but if the contacts of relay TRR DL were by-passed, then, when a train entered track circuit DL, signal WF138 would fail to turn to red and would instead show a proceed aspect. Thus, a driver would be given a totally false indication that it was safe to proceed.

Fig 15. Extract from the working model demonstrating jobs 104 and 201 and the wiring errors made. The black wire along the top of the diagram connected at DM TRR and Row 12-f107 should have been disconnected at both ends but was wrongly left connected at the fuse end at Row 12-f107. Although disconnected at the relay end the wire was left loose and made metal-to-metal contact at DM TRR allowing a false feed of current to by-pass DL TRR. Hence the occupation of track circuit DL by a train had no effect on signal WF 138 and it did not turn back to red as it should have done.

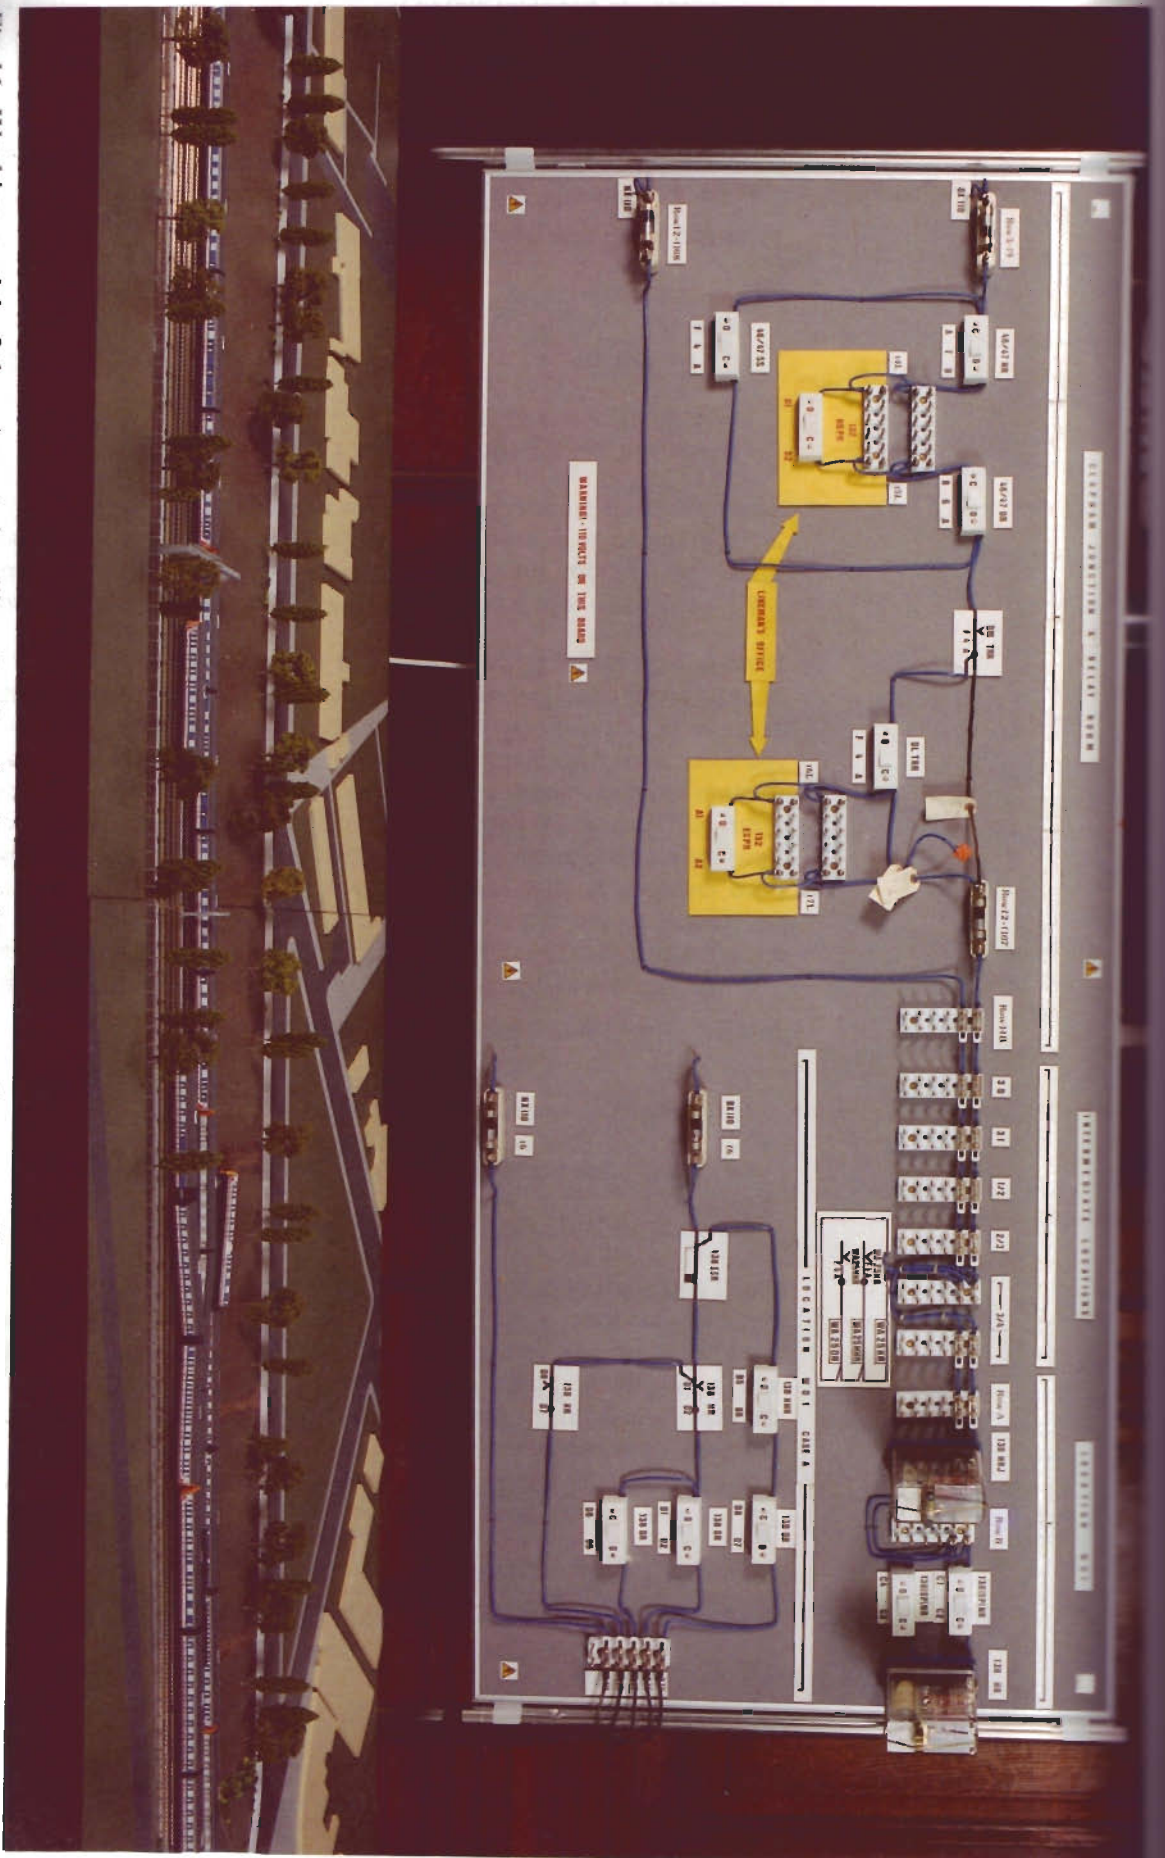
Fig 16. Working model of the relevant signalling circuits, showing wiring errors; and topographical model of the crash site.
