DEPARTMENT OF TRANSPORT

# Investigation into the Clapham Junction Railway Accident

Anthony Hidden QC

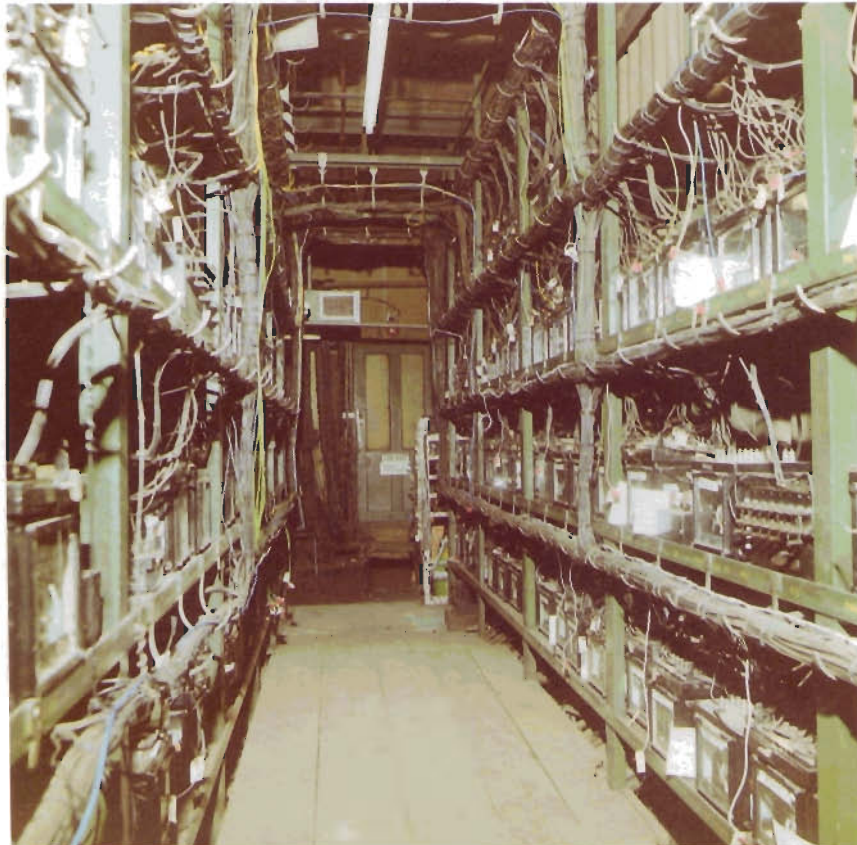
1.16 The relay room at the end of Clapham Junction "A" signal box is only a few yards wide throughout its length (see Figure 11). Whereas the next door Signal Box has good natural light through windows on either side, there is no natural light in the relay room, which is lit by fluorescent lighting from the ceiling. This, while giving enough light for visual observation of the relays and the fuses, presents a rather gloomy appearance and requires additional light for detailed electrical work.

1.17 Inside the door there is a passageway on either side of which are four tiers of wooden racks which carry the many relays upon which the system depends (see Figures 11 and 12). There are six bays of racking on the way to the far end of the relay room and on each shelf in each bay there is room for four relays. These relays are a little larger and heavier than an average car battery and have glass sides so that their physical operation can be visually checked.

*Fig 11.* A view of the relay room, looking towards the entrance, showing the relay racks, and the trees of the wiring. Relays TRR DM and TRR DN are on the bottom shelf on the right in the last section towards the door.

7.37 The work involved wires which ran from the same “tree” as the wires to TRR DM. (The “trees” are the collection of wires that can be seen running horizontally along the racks and vertically along the upright divisions in Figure 11). The work also involved physical manhandling of the relays themselves. The work had the unforeseen and unwanted result of disturbing the wires in the vicinity of TRR DM. The most unwanted effect of all was to permit the bare uninsulated end of the old “black” wire, left in that condition by Mr Hemingway two weeks before, to revert to the natural position it had held over many years. It went back to lie against and in contact with the terminal which had been its previous home under the old system when it had been designed to pass current to fuse 107. It was still connected to that fuse and now it could and did again pass current directly to it, and out of the relay room down to the signal WF138.

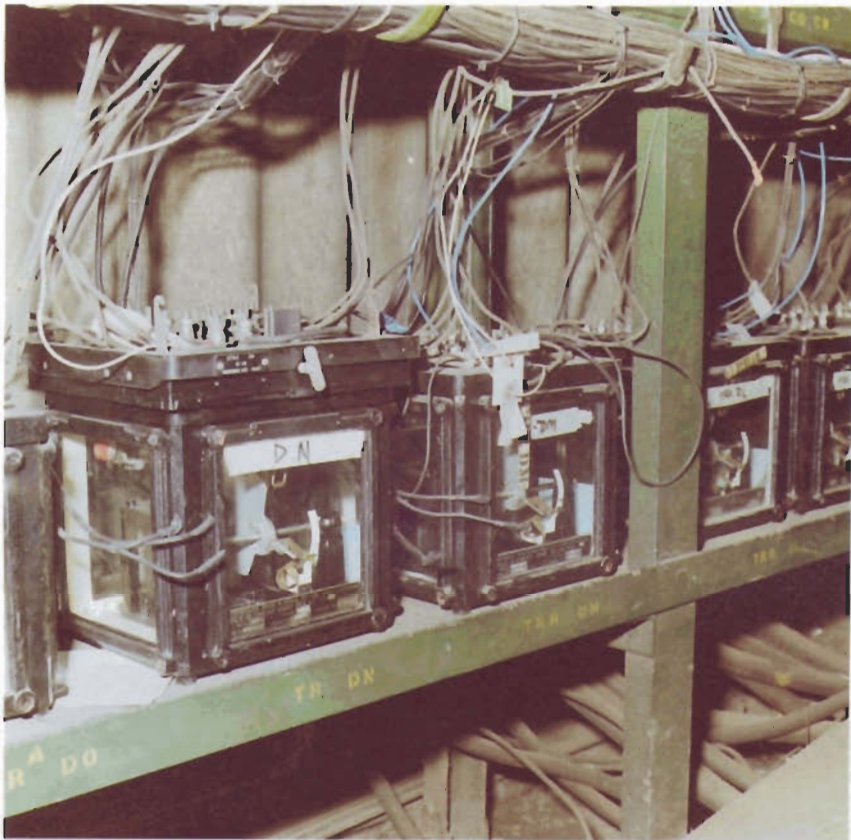
**Fig 12.** Relays in Clapham Junction 'A' relay room, showing track relay 'DN' adjacent to track repeater relay 'DM'.

7.36 On Sunday, 11 December, further work came to be done in that relay room which had nothing to do with Job Nos. 104 and 201. However, by a coincidence that was to be catastrophic the job involved work in the immediate vicinity of the relay TRR DM. The task was to replace the adjoining relay TR DN with another unit. These relays are a little larger and heavier than a conventional car battery. They can be seen in Figure 12, TR DN being to the immediate left of TRR DM. This work involved not only the movement of individual wires in their transfer to the new relay, but also the physical movement of the old and new relays themselves. The existing relay was pushed bodily towards the back of the shelf and the detachable top of the new relay was placed on a convenient piece of wood at the front of the shelf. Once the wiring work was completed the old relay was moved out and the new relay moved into its place. It was again pure coincidence that it was Mr Hemingway who had to do this work: this time his assistant was not Mr Dowd.

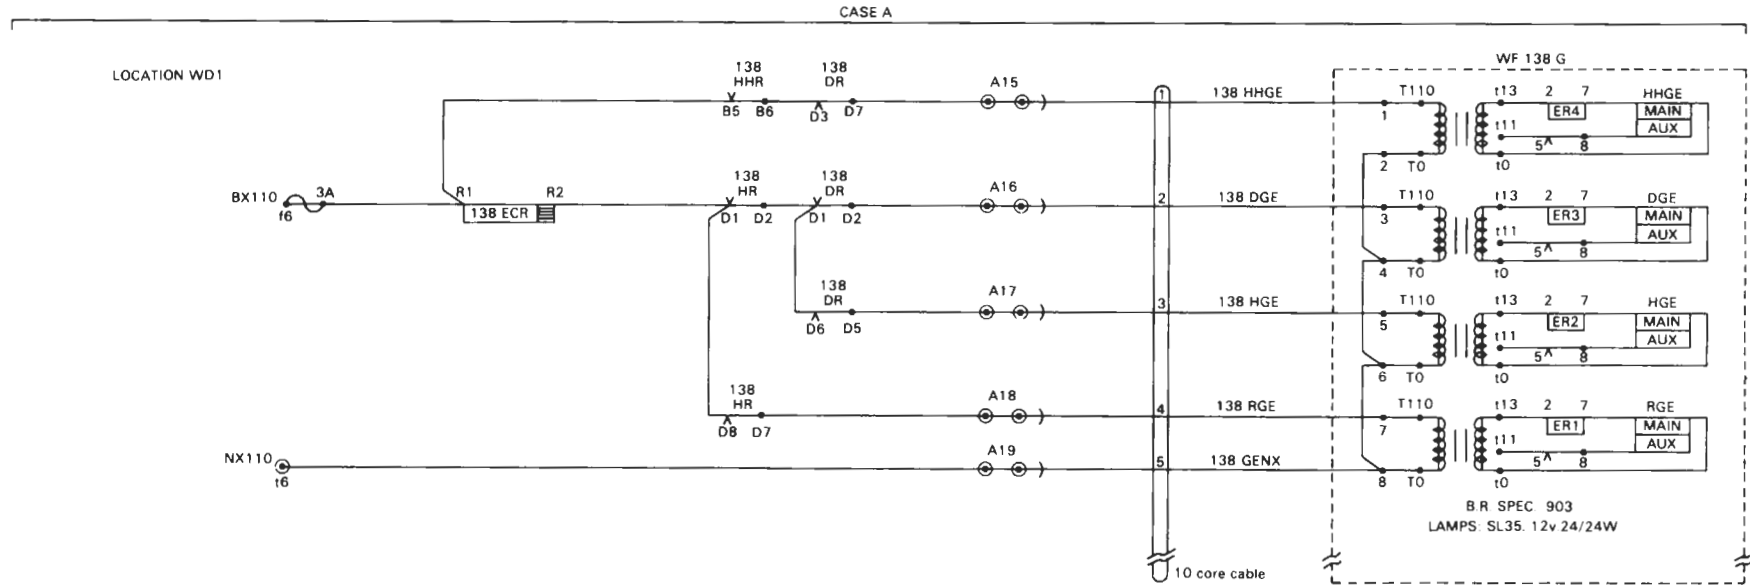
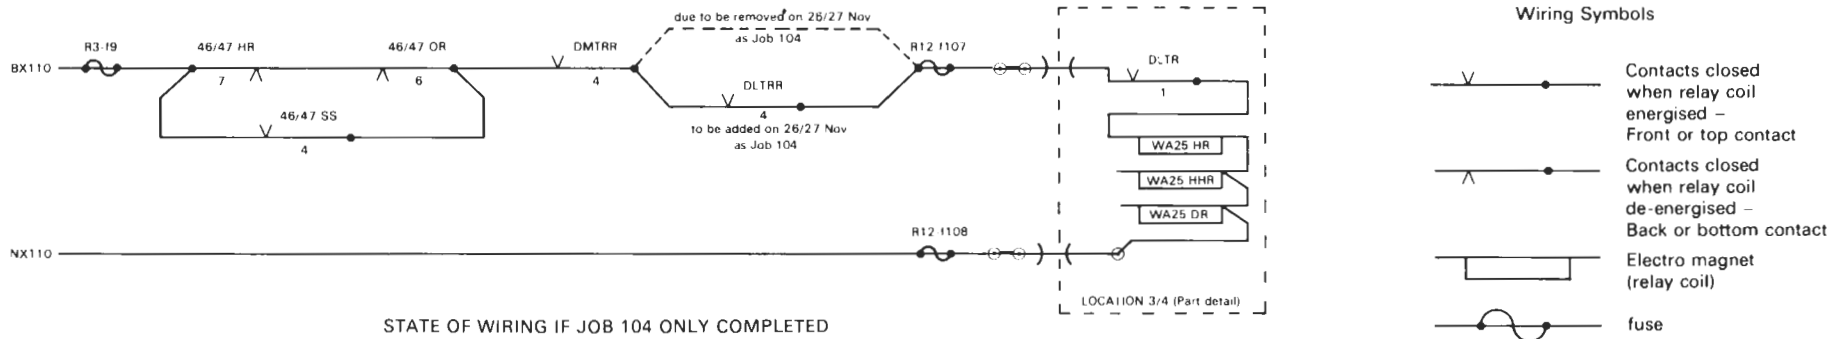
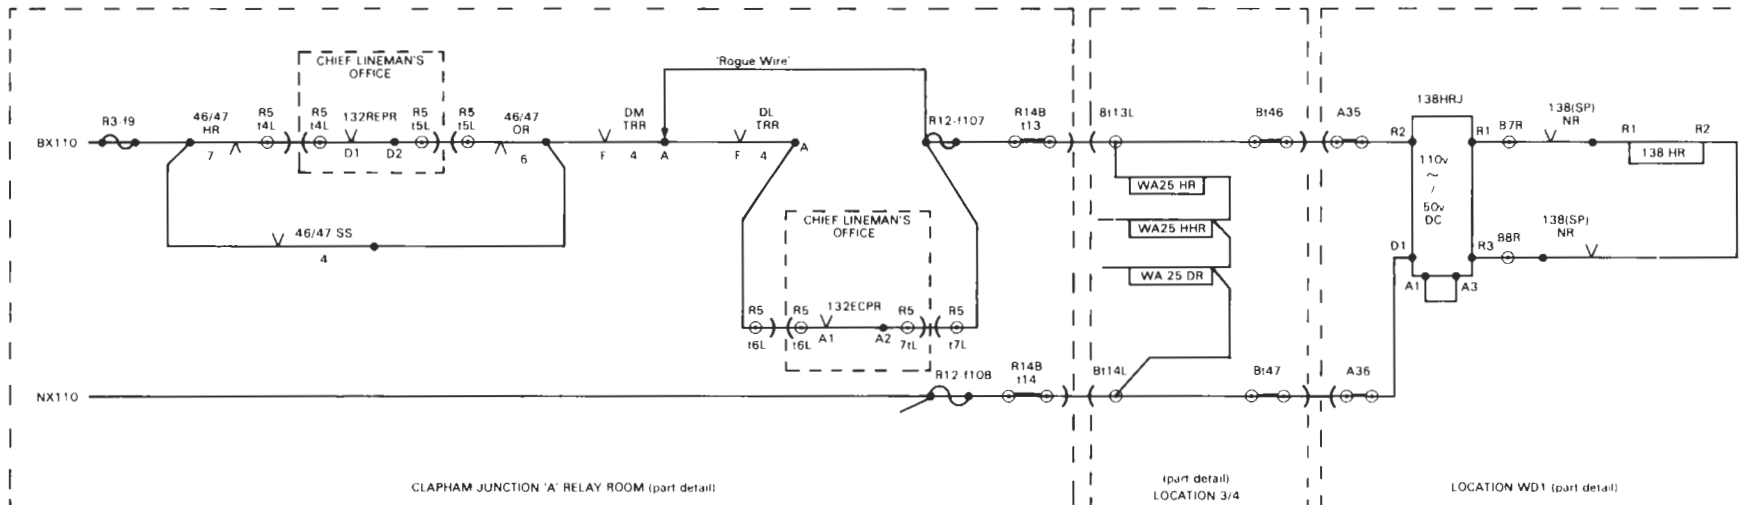
Clapham Junction 'A'  
Part Detail of Control Circuits  
For Automatic Signal WF 138.

CONTROL CIRCUITS FOR SIGNAL WF 138

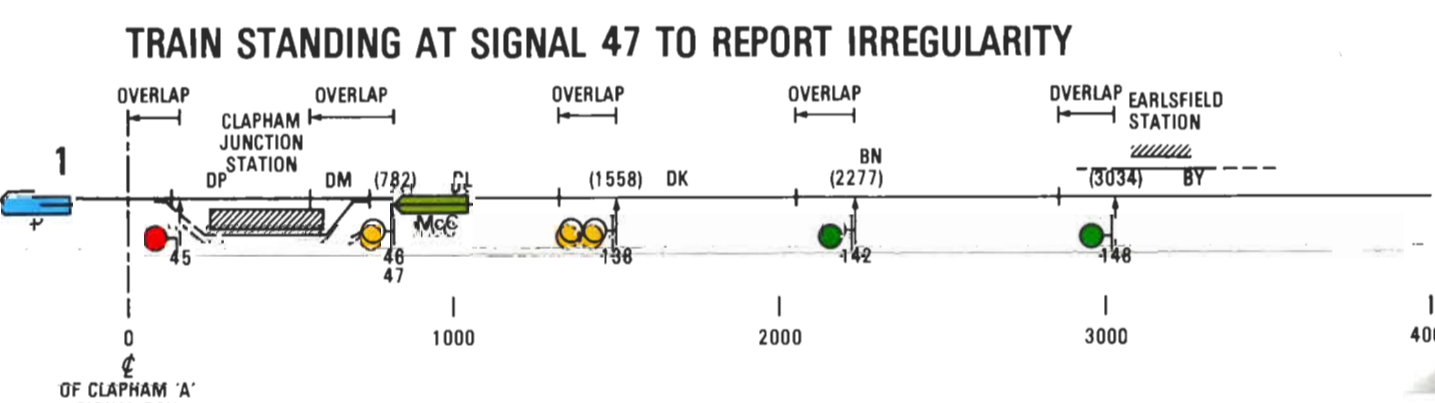
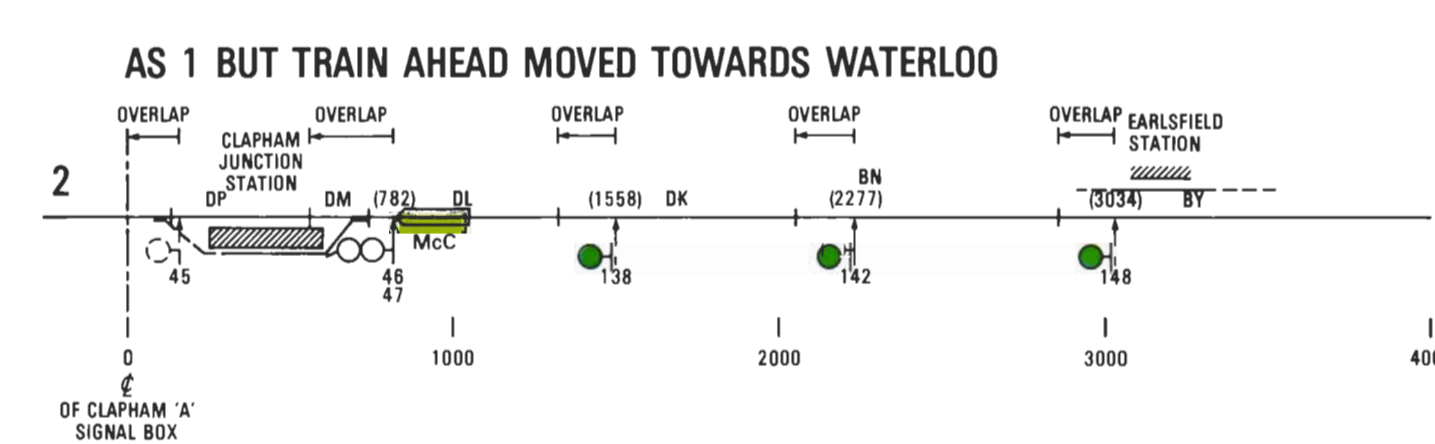
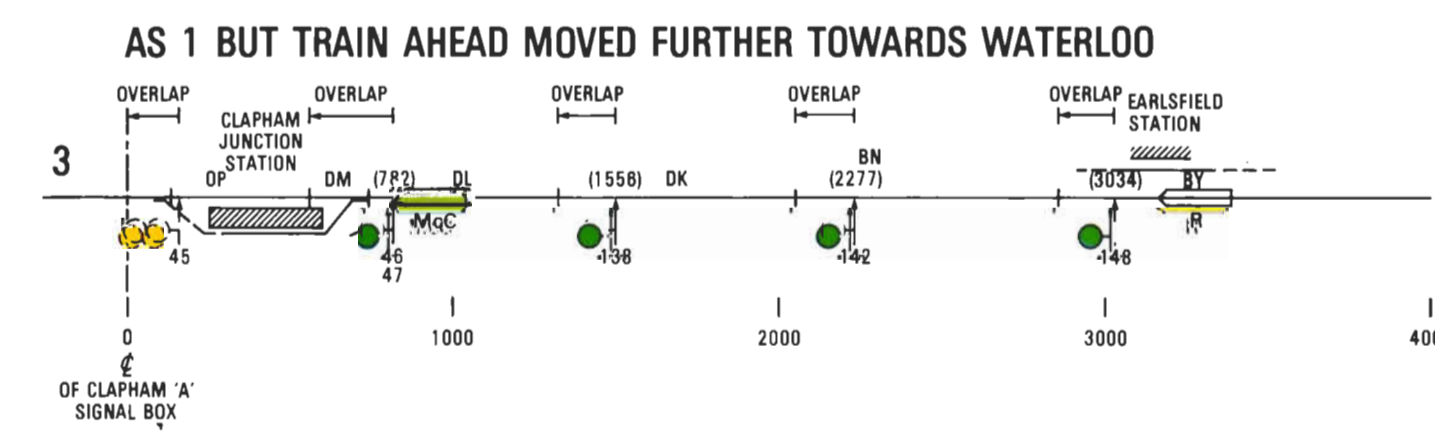
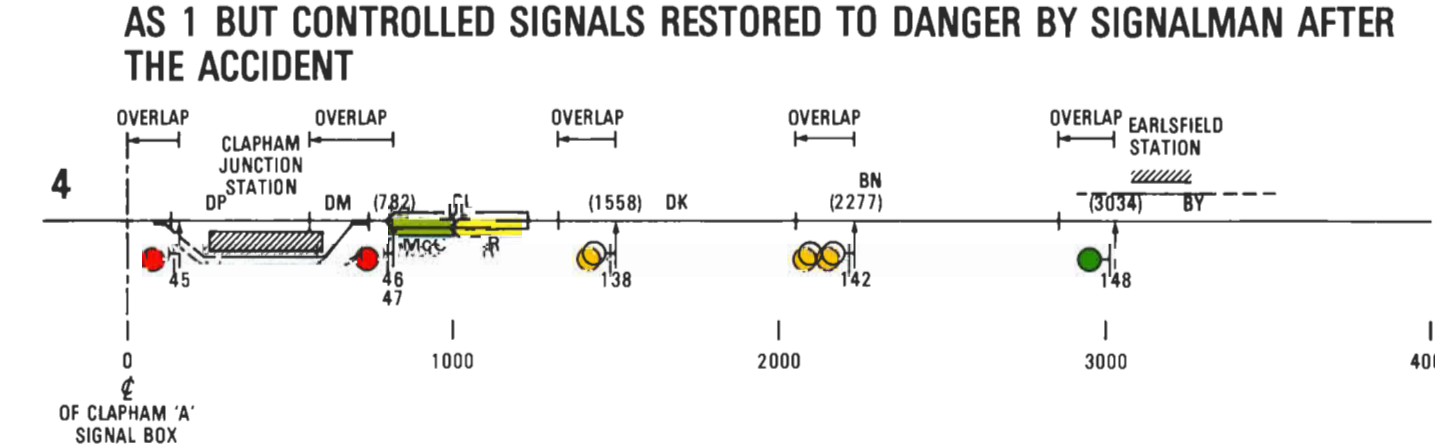
(D) ASPECT SEQUENCE OF SIGNALS IMMEDIATELY BEFORE AND AFTER THE ACCIDENT

- Mr. Christy's train
- Mr. Priston's train
- Mr. McClymont's train
- Mr. Roll's train
